NRL/MR/6180--04-8742

# Performance of Fire Protective Coatings Subjected to DC-ARM Wartime Scenario Fires Aboard Ex-USS *Shadwell*

January 16, 2004

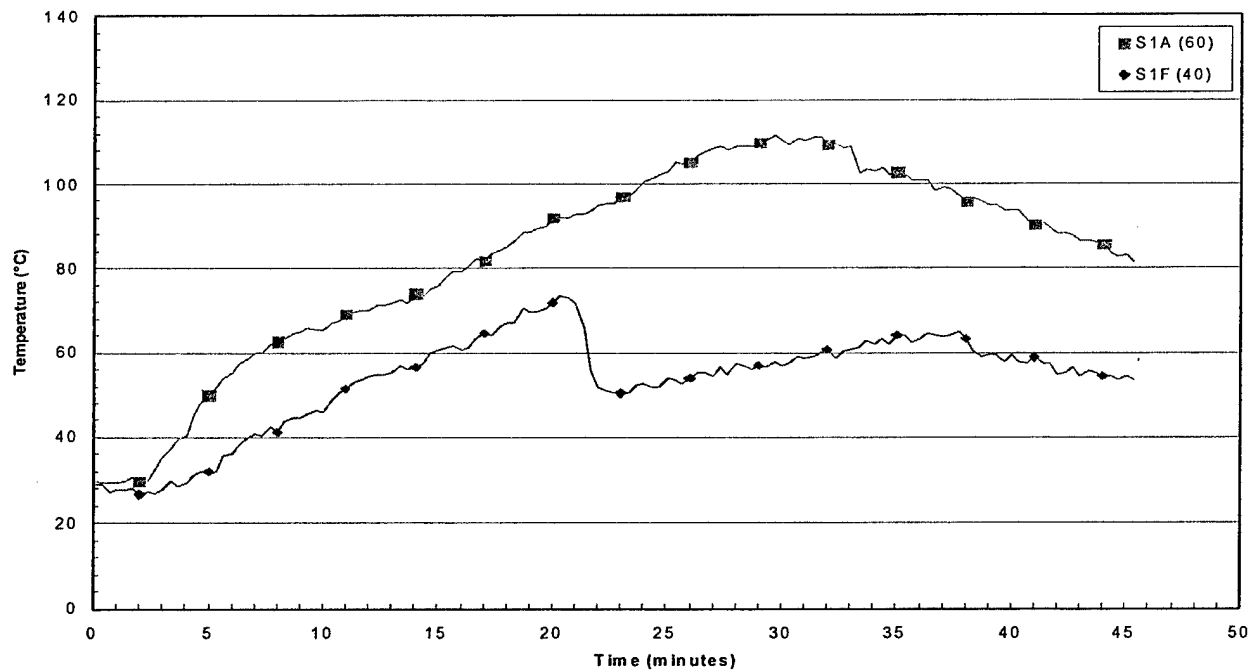
**Figure 7. Temperature Profile, Panel #1**

Prior to the 21-minute mark of the test, both forward and aft side, thermocouples display a nearly identical rate of increase at approximately 2 °C/min (3.7 °F/min) (Figure 7). From 23-30 minutes of the test, the aft side thermocouple continues to register a nearly identical 2 °C/min (3.7 °F/min) rate of rise while the forward side thermocouple registers a 0.4 °C/min (0.72 °F/min) rate of rise. The reduced rate of rise in forward surface temperature, beyond the 23-minute point, is further indication that a localized increase in convective cooling had occurred.

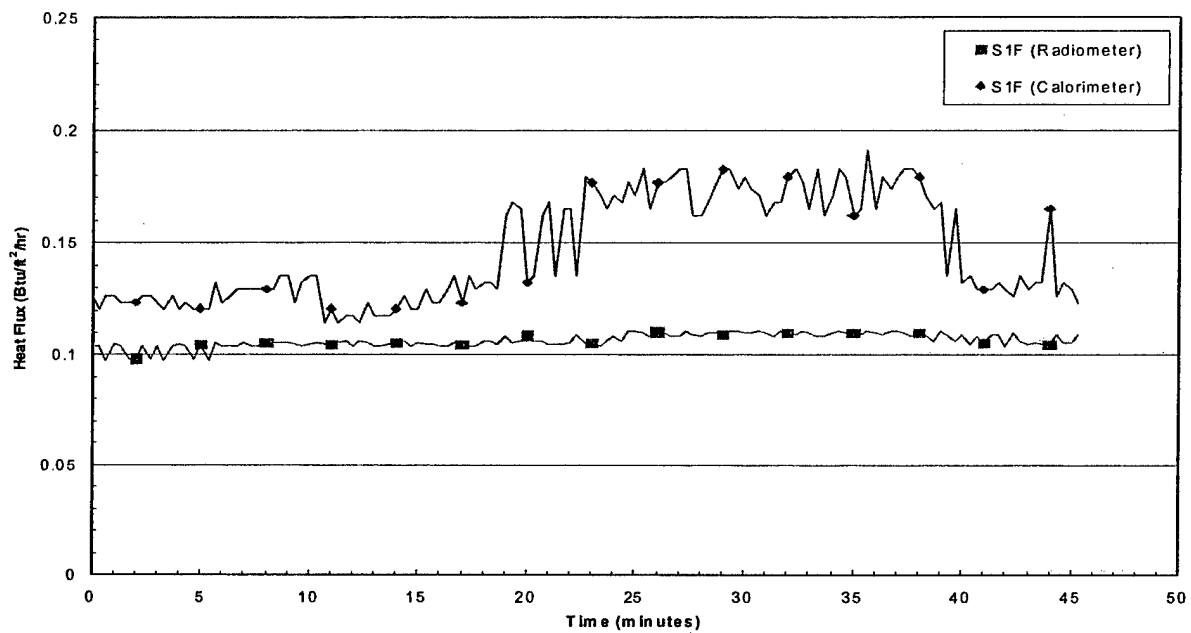
**Figure 8. Heat Flux Profile, Panel #1**

The upper data plot in Figure 8 is the sum of radiant and convective flux. The thermally driven velocity profile just described would have increased the convective heat transfer coefficient ( $h$ ) across the forward surface of test panel 1. The increase in ( $h$ ) would have increased the magnitude of the convective heat flux measured on the forward surface of this panel. This is exactly what is shown implicitly by the raw data and explicitly when equation 4 is applied to these two data traces.

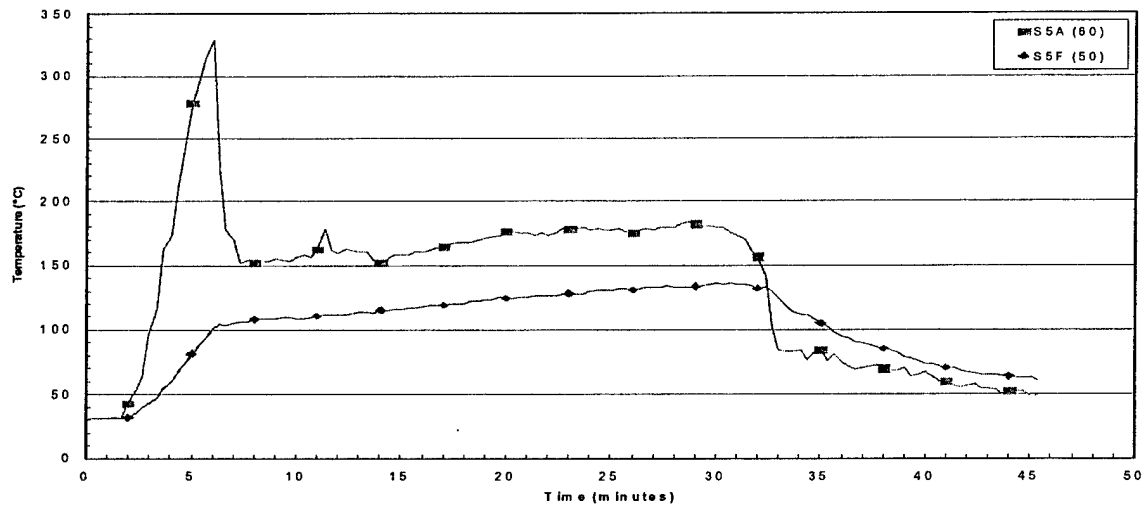
Figure 25. Temperature Profile Panel #5

Figure 25 shows the fireside bulkhead thermocouple rising rapidly from an ambient temperature of 31 °C (88 °F) to a maximum of 330 °C (594 °F) and then back to a temperature of approximately 153 °C (307 °F) in a period of approximately 6 minutes. Based on post test inspection of the coating it has been determined that the initial rate of temperature rise due to the 5 gallon heptane pool fire, approximately 75 °C/min (126 °F/min), was insufficient to activate a large scale intumescent response across the aft surface of this particular panel.

There are two possible explanations for the rapid rise and fall of the fire side surface thermocouple temperature profile (Figure 25). The first explanation is localized burning of evolved organic vapors. The second explanation is a fluctuating burn rate of the 30 cm x 76 cm (12 in. x 30 in.) heptane pool. The current understanding is that fire compartment ventilation has a measurable impact on pool burning rates, heat release rates and species production (Refs. (11) - (12)). An increase in products of incomplete combustion (smoke, CO) is some indication that there was a decrease in ventilation to the fire.

After the brief temperature "spike," the forward and aft side thermocouple exhibited a nearly identical rate of rise, 1.3<sup>0</sup>F/min), up to the 29 minute point in the test. The temperature

differential between aft and forward surface of this panel remained a nearly constant 49<sup>0</sup>C (120<sup>0</sup>F) from 7-29 minutes of the test.

The bottom traces of Figure 25 and Figure 36 represent the surface temperature measurement on the non-fire side of panels 5 and 6 respectfully. As with panels 1 and 2, there appears to be no clear benefit afforded by the application of the Temp Coat product. In fact, the surface treated with Temp Coat reaches a higher maximum temperature than does the bare surface. This appears contradictory when one realizes the fire side of the untreated panel attained a higher, average surface temperature for a longer period of time than did the fire side surface of the Temp Coat treated panel. No clear conclusion could be reached to explain the phenomena because there was only one test conducted.

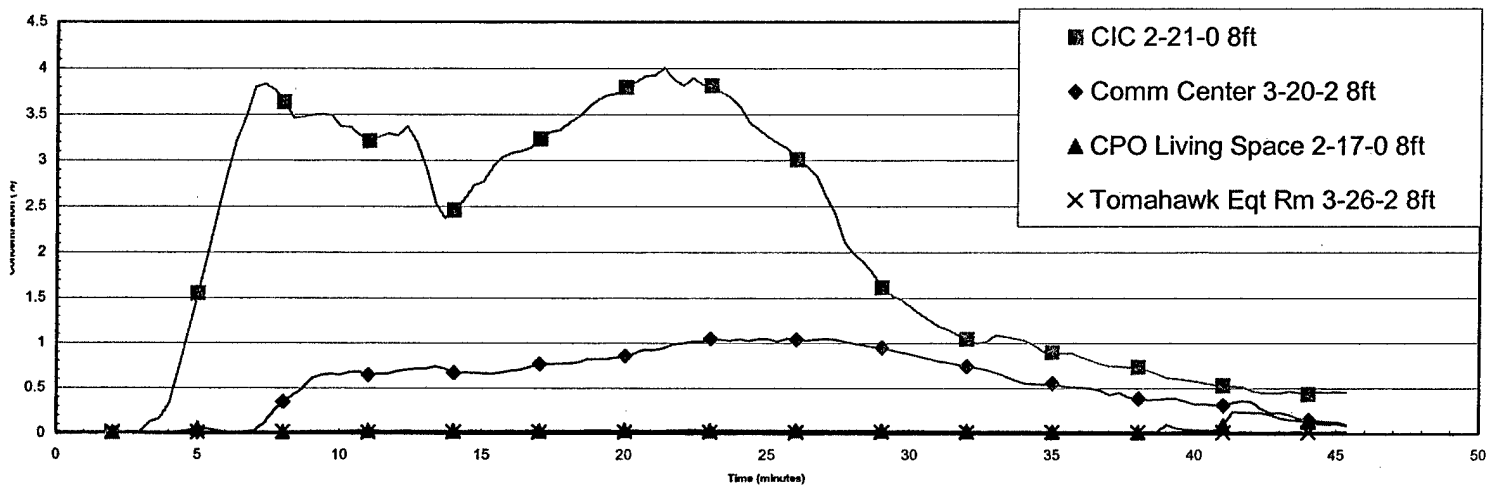
Figure 26. CO Concentration Profiles

For the test being discussed, a cyclic variation in fire compartment ventilation seems to be indicated by the time history of compartment CO concentration. The top trace of Figure 26 shows a rise and fall of CO concentration high in the fire compartment. A decrease in ventilation also seems to be indicated by a decrease in burning rate of the heptane pool, reflected in the top trace of Figure 27, and a decrease in burning rate of the combined ALPHA/BRAVO fire as seen in the upper thermocouple trace of Figure 28. The upper thermocouple trace in Figure 27 is data collected approximately 152 cm (60") above the seat of the combined ALPHA/BRAVO fire at frame 20.

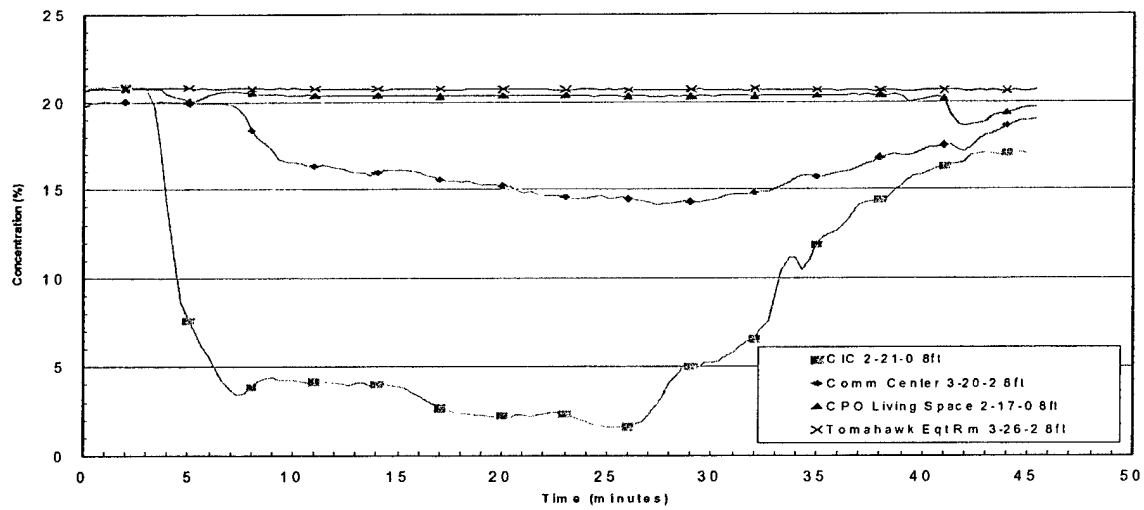
**Figure 29. Oxygen Concentration Profiles**

Further indication of a ventilation restricted burn can be seen in the bottom two traces of Figure 29. The sampling locations were 2.5 m (96") above the fire compartment deck and approximately 0.3 m (12") below the seats of the test fires. There were two large penetrations in the deck of the fire compartment immediately aft of the heptane pool. These large penetrations would have allowed free communication of the atmospheres between compartments 2-17-0 and 3-15-0. The oxygen measurement attributed to compartment 3-20-2 was, physically, directly below and between the seats of both test fires. The oxygen profile for the 3-20-2 location would have been, due to physical proximity alone, a close approximation of the available oxygen at the seats of these fires.

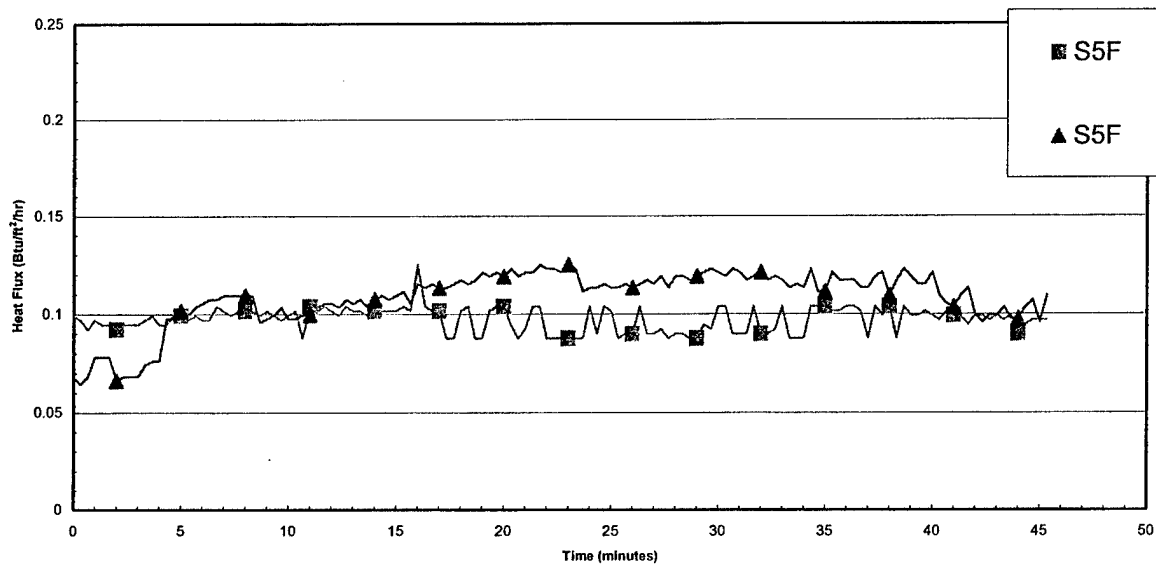
**Figure 32. Heat Flux Profiles Panel #5**

Figure 32 displays measurements of radiant and total heat flux from the forward surface of test panel 5. The erratic 12% fluctuation in the radiative flux component, lower trace, seems to correspond with the previously discussed increase in free convection.

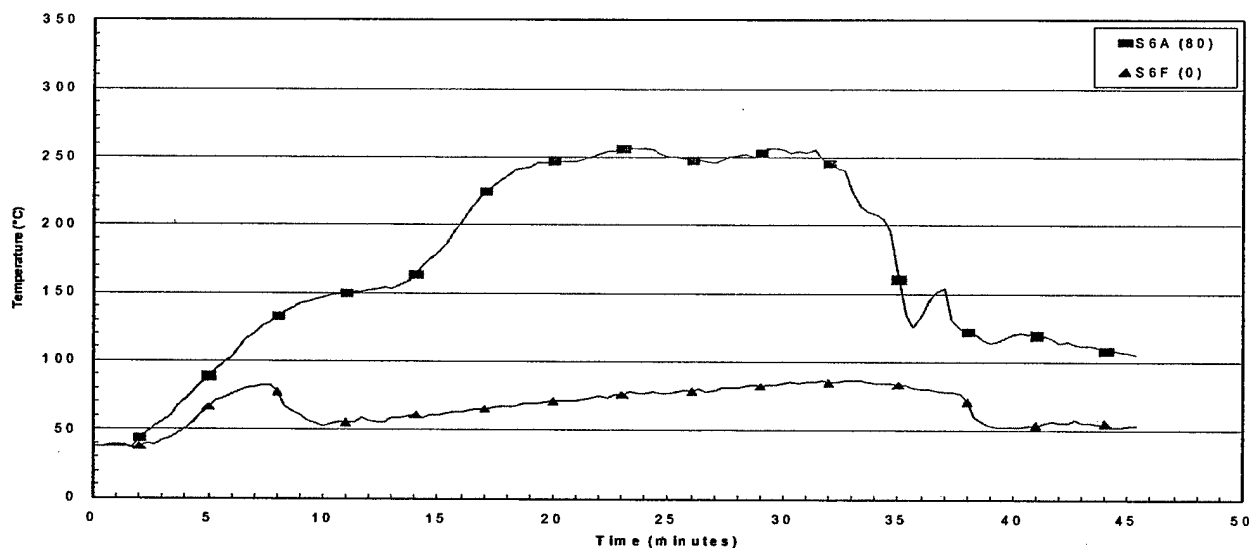
Figure 36. Temperature Profile, Panel #6

The forward side thermocouple (Figure 36) exhibits an initial rise of  $6.25^{\circ}\text{C}/\text{min}$  ( $11.25^{\circ}\text{F}/\text{min}$ ), to a maximum of  $84^{\circ}\text{C}$  ( $183^{\circ}\text{F}$ ) prior to the  $31^{\circ}\text{C}$  ( $88^{\circ}\text{F}$ ) drop in temperature at 8 minutes. After this drop the forward side thermocouple exhibits a consistent  $1.5^{\circ}\text{C}/\text{min}$  ( $2.7^{\circ}\text{F}/\text{min}$ ) rate of rise through the duration of the test. The maximum temperature differential across this bulkhead is approximately  $178^{\circ}\text{C}$  ( $352^{\circ}\text{F}$ ), occurring at 20 minutes into the test.

The temperature differential across this test panel (Figure 36) became significant at approximately 8 minutes into the test when the forward side thermocouple registered a  $30^{\circ}\text{C}$  ( $86^{\circ}\text{F}$ ) drop in temperature. Post test inspection of the panel determined that the fireside thermocouple was within the blistered region. This can be seen by close inspection of the bottom left hand corner of Figure 34. At the same time the forward surface thermocouple recorded the temperature drop, the level of radiant heat flux leaving the forward surface was recorded at a fairly stable ( $0.082\text{ Btu}/\text{ft}^2/\text{hr}$ ) level (Figure 37). Considering the radiant flux leaving the forward side of the panel was stable during the recorded drop in temperature, it seems unlikely that loss of energy due to radiation would be the source of the observed temperature drop. In addition, the drop in temperature cannot be attributed to the previously discussed increase in free convection because the two events are separated by at least 12 minutes. The only remaining, logical, conclusion as to what influenced the measured temperature decrease, is blistering of the aft side coating.

measured on the bare, forward side of panel 6 (Figure 36). No correlation can be drawn between the measurements made at 66 inches above the deck on the forward side of panel 7 (Figure 45) and those made at 23 inches above the deck on the forward side of panel 6 (Figure 36).

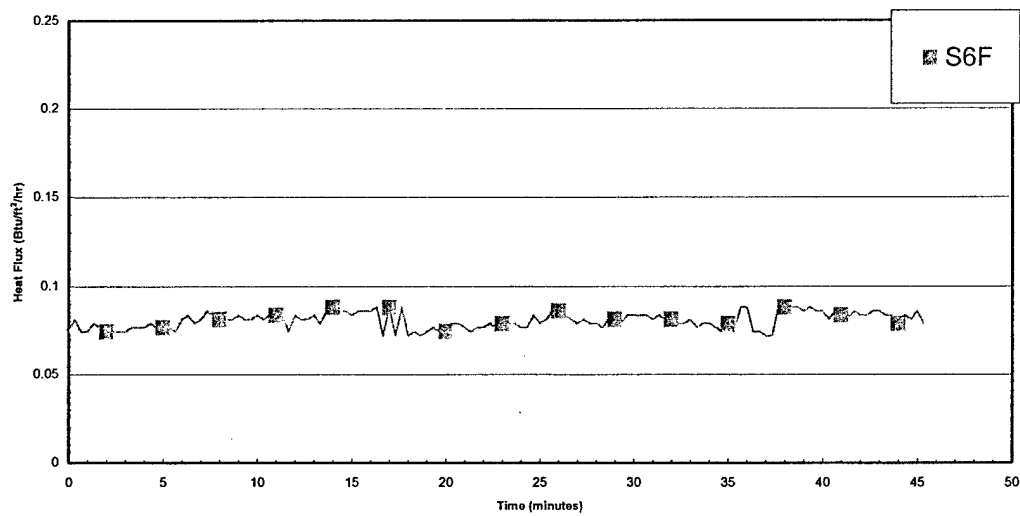
**Figure 37. Heat Flux Profile, Pane #6**

Btu/ft<sup>2</sup>/hr level (Fig. 37) considering the radiant flux leaving the forward side of the pane was stable during the recorded drop in temperature, it seems unlikely that loss of energy due to radiation would be the source of the observed temperature drop. In addition the drop in temperature can not be attributed to the previously discussed increase in free convection because the two events are

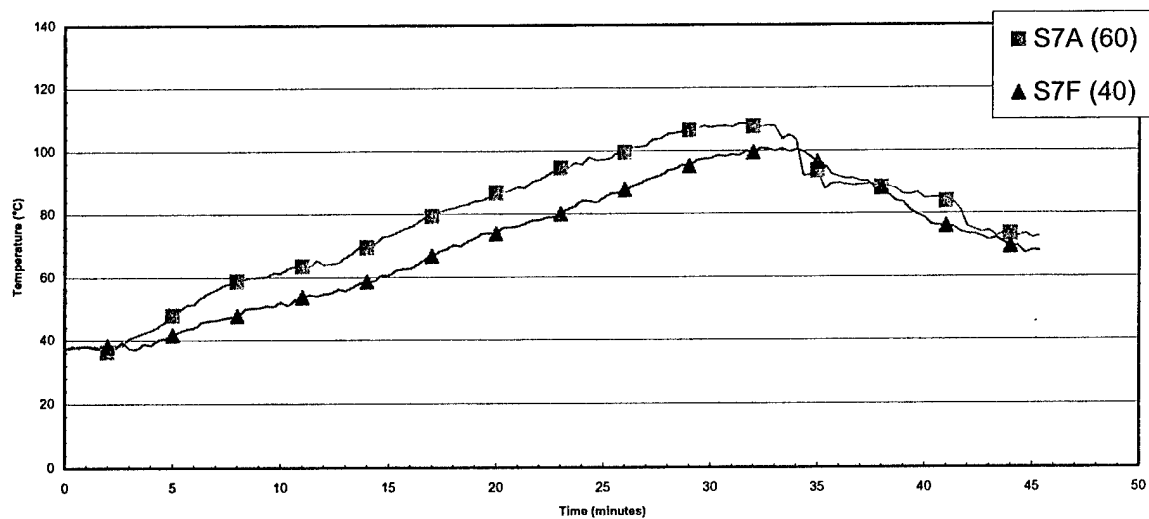
**Figure 43. Temperature Profile, Panel #7, 16" Above Deck 60 Mil Fire Barrier 2-Vs. 45 Mil Temperature Coat**

Figures 43-45 are temperature measurements taken at 3 different locations within the same test panel. Figure 43, measured 16" above the deck shows a nearly identical rate of temperature rise at 2.2 °C/min (3.9 °C/min) for the forward thermocouple versus 2.4 °C/min (4.4 °F/min) for the aft thermocouple. The temperature differential, at the measurement point, between the forward and aft faces of this test panel was 6°C at 5 minutes, 15 °C at 17 minutes and 12 °C at 29 minutes.

The bottom traces of Figure 43 and Figure 44 show there was little apparent benefit to application of the Temp Coat product. The maximum surface temperatures on the Temp Coat treated forward side of panel 7 (Figures 43 and 44), were not significantly different than those

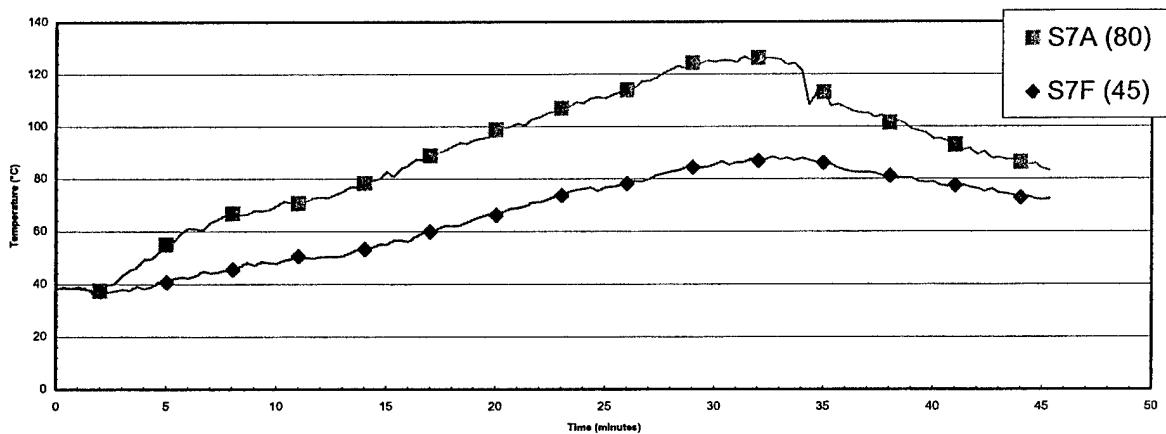
**Figure 44. Temperature Profile, Pane #7, 27" Above Deck 80 Mil Fire Barrier-2 Vs. 45 Mil Temperature Coat**

Figure 44, measured 27" above the deck, shows the fireside bulkhead temperature rising at an average of 2.9 °C/min (5.3 °F/min) while the forward side temperature rises at 1.8 °C/min (3.2 °F/min). The temperature differentials were 13 °C (55 °F) at 5 minutes, 30 °C (86 °F) at 18 minutes and 40 °C (104 °F) at 29 minutes.

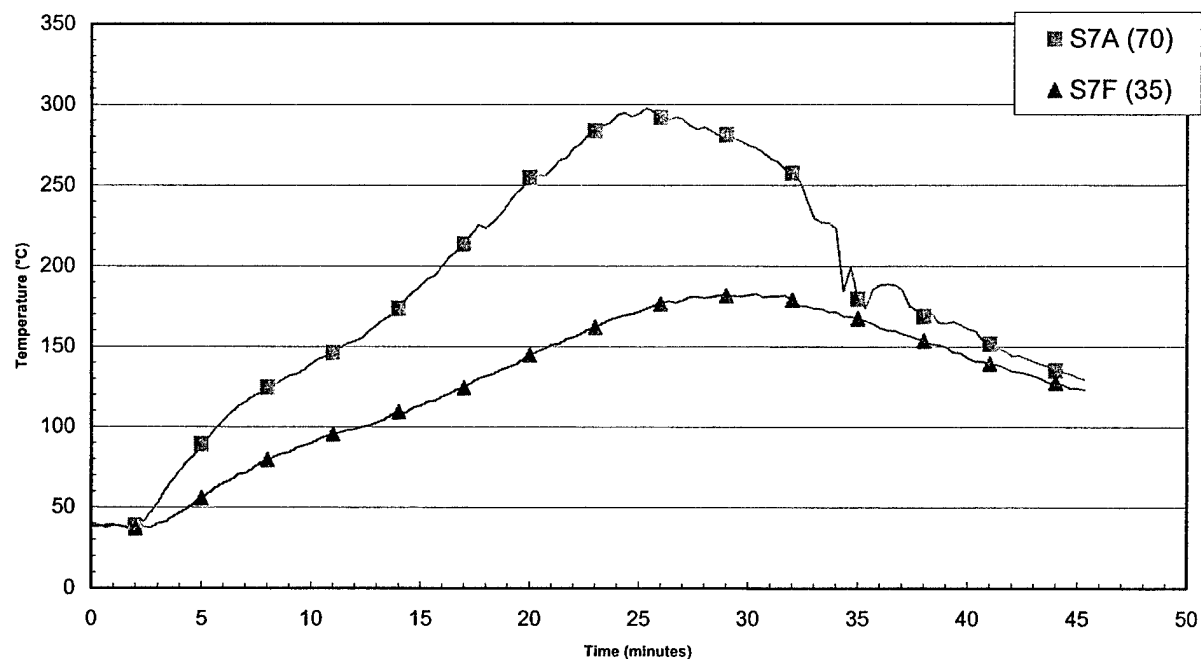
**Figure 45. Temperature Profile, Panel #7, 66" Above Deck 70 Mil Fire Barrier-2, Vs. 35 Mil Temperature Coat**

Figure 45, measured at 66" above the deck, shows the fireside thermocouple temperature rise being 10.9 °C/min (19.6 °F/min) while the forward side rise is 6 °C/min (10.8 °F/min). The temperature differentials were 33 °C (91 °F) at 5 minutes, 75 °C (167 °F) at 15 minutes and 126 °C (259 °F) at 24 minutes.
